MONITORING OF AQUATIC HABITATS VEGETATION

Danube Monitoring Scientific Conference Publication, Slovak Section, chapter:

**V.2.8. Monitoring the vegetation of aquatic habitats influenced
by the Gabčíkovo project**

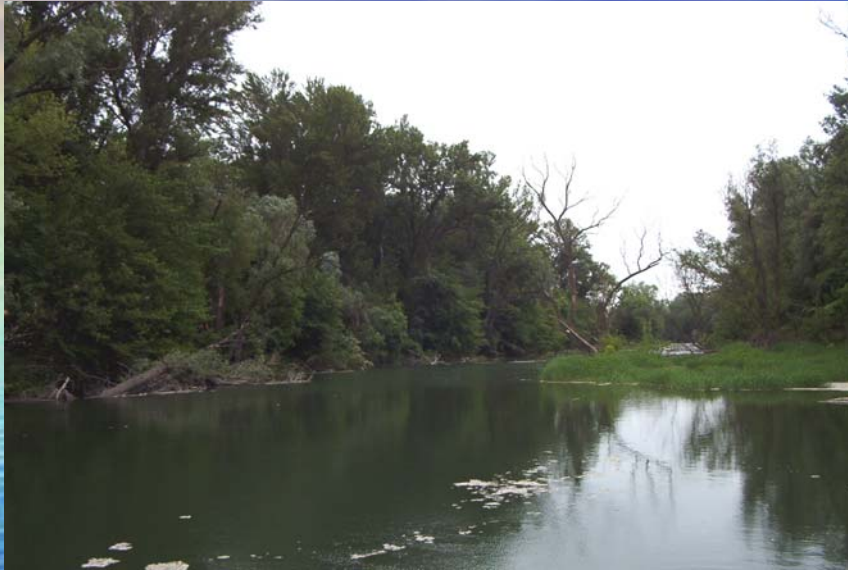
MP 2B Rusovské ostrovy

- sporadic macrophytes occurrence
- submerged and natant pleustophytes predominate:
Ceratophyllum demersum, *Lemna minor*, *Spirodela polyrhiza*

- situated close to the Čunovo reservoir
- 1989-90: the drying up remnant of the Rusovské rameno arm
- at present: a polder surrounded by deep, permanent flooded arm discharging during floods

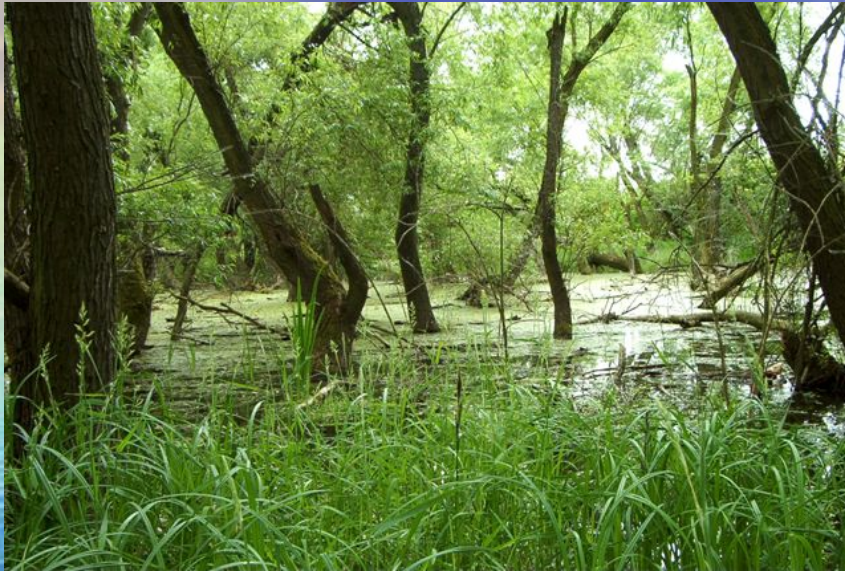
MP 3 Čunovo – Ostrovné lúčky

- in 1997 first hydrophyte species *Lemna minor* occurred
- in 2005 eight hydrophyte species was recorded
- *Lemna minor* and *Riccia fluitans* predominate
- tree layer (*Salix fragilis*, *S. alba*) dies out (70% → 25%)

- situated close to the Čunovo reservoir
- 1989-90: the dried up arm covered by a softwood floodplain forest
- since 1996 permanent flooded by stagnant water
- water level height of 30-50 cm

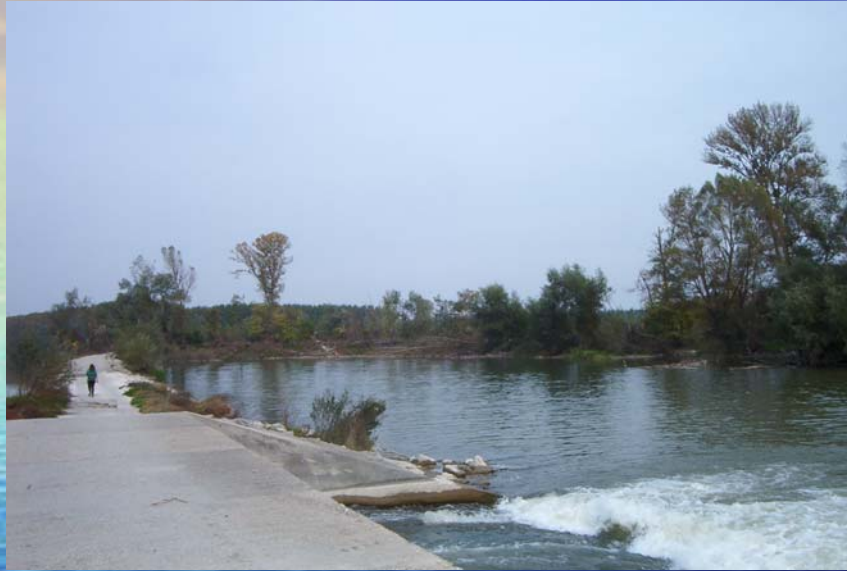
MP 9 Bodíky – Bodícka brána

- macrophytes occur only in the littoral protected against drifting
- *Ceratophyllum demersum*, *Elodea nuttallii* and *Myriophyllum spicatum* predominate
- populations are strongly eliminated during floods but relatively fast regenerate

- the stretch of the Šulianske rameno arm situated in the within-dike zone between the bypass canal and the Danube
- 1989-90: sometimes discharging with the strongly fluctuated water level and rare occurrence of macrophytes
- at present: the deep discharging arm with the stable water level during the whole year

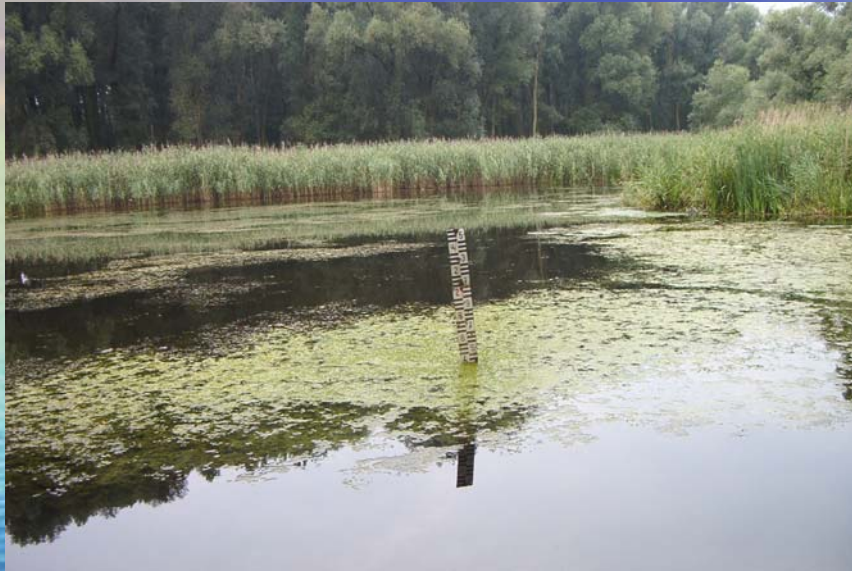
MP 10 Královská lúka

- 1989-90: *Nymphaea alba*, *Trapa conocarpa*, *Nuphar lutea*, *Ceratophyllum demersum* and *Potamogeton perfoliatus* dominated
- at present: only *C. demersum* and *N. alba* are dominant species

- the relic of the Danube arm situated in the within-dike zone between the bypass canal and the Danube
- 1989-90: flooded and overgrown with macrophyte species
- at present: the similar status

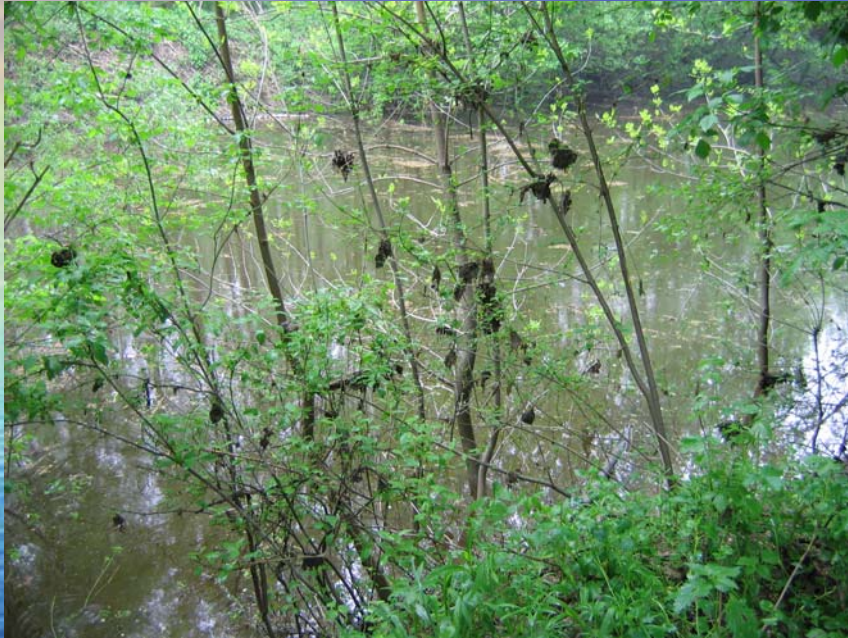
MP 14 Istragov

- hydrophytes don't occur in this MP
- *Phalaris arundinacea*, *Agrostis stolonifera*, *Polygonum* spp., *Carex* spp. predominate
- also the wildings of trees appear (especially *Acer negundo*)

- the peripheral arm of the island situated in the within-dike zone between the bypass canal and the Danube
- 1989-90: flooded
- at present: the water level decline under the surface

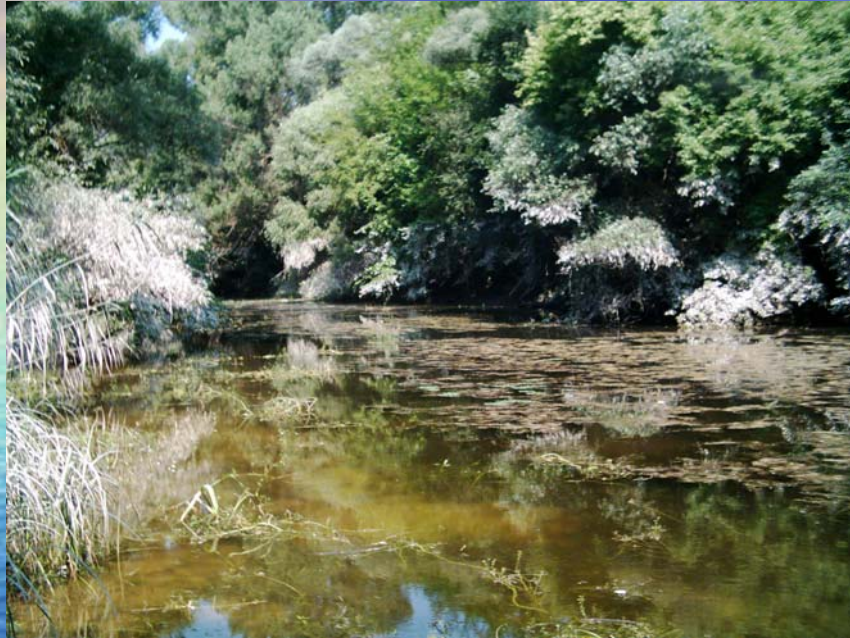
MP 18 Klúčovec – Sporná síhoť

- *Ceratophyllum demersum*, *Batrachium circinatum*, *Elodea nuttallii*, *Trapa natans* are dominant species
- the large growths of rare species *Hippuris vulgaris* and *Scirpus radicans* was recorded

- the cut-off branches of the Opátske (Klúčovské) rameno arm situated in the within-dike zone, downstream of the confluence of the tailrace canal with Danube
- 1989-90: flooded and overgrown with many macrophyte species
- at present: the same status

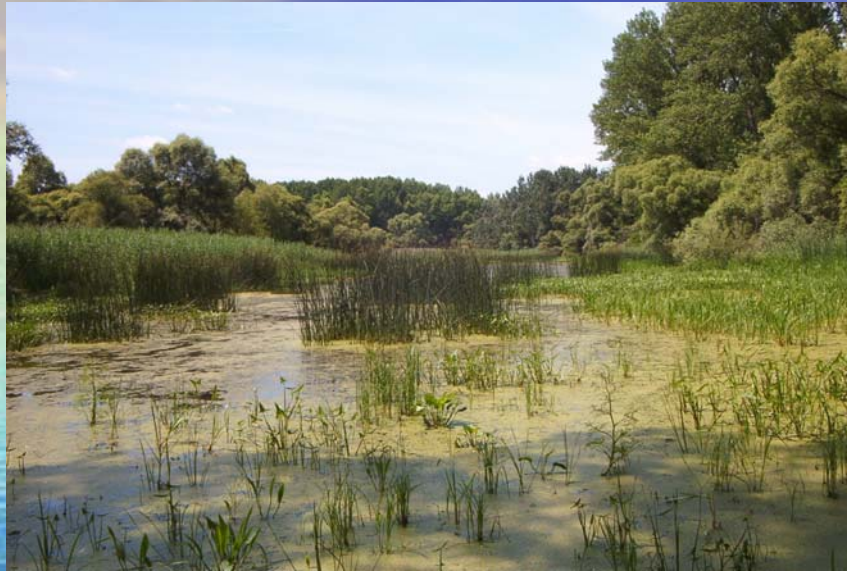
MP 23 Číčov – Starý les

- the dominant species are:
Potamogeton lucens, *P. pectinatus*, *P. pussillus*, *Salvinia natans*, *Lemna minor*,
Spirodela polyrhiza, *Batrachium trichophyllum*, *Nymphoides peltata*,
Carex gracilis, *Rorippa amphibia*,
Oenanthe aquatica, *Glyceria maxima*

- the relic of the Danube oxbow situated in the within-dike zone, downstream of the confluence of the tailrace canal with Danube
- 1989-90: the locality was influenced by the water level decreasing
- at present: flooded and overgrown with many aquatic plant communities
